RE: N00014-14-1-0789 Final Report

1. REPORT DATE (DD-MM-YYYY) 28-09-2017			2. REPORT TYPE Final		3. DATES COVERED (From - To) 01-07-2014 - 28-09-2017	
4. TITLE AND SUBTITLE Technology Insertion for Recapitalization of Legacy Systems Program Final Report					5a. CONTRACT NUMBER	
					5b. GRANT NUMBER N00014-14-1-0789	
					5c. PROGRAM ELEMENT NUMBER

Research Program 1:
Effect of Corrosion on Physical Properties
of Highly Stressed Coated Components

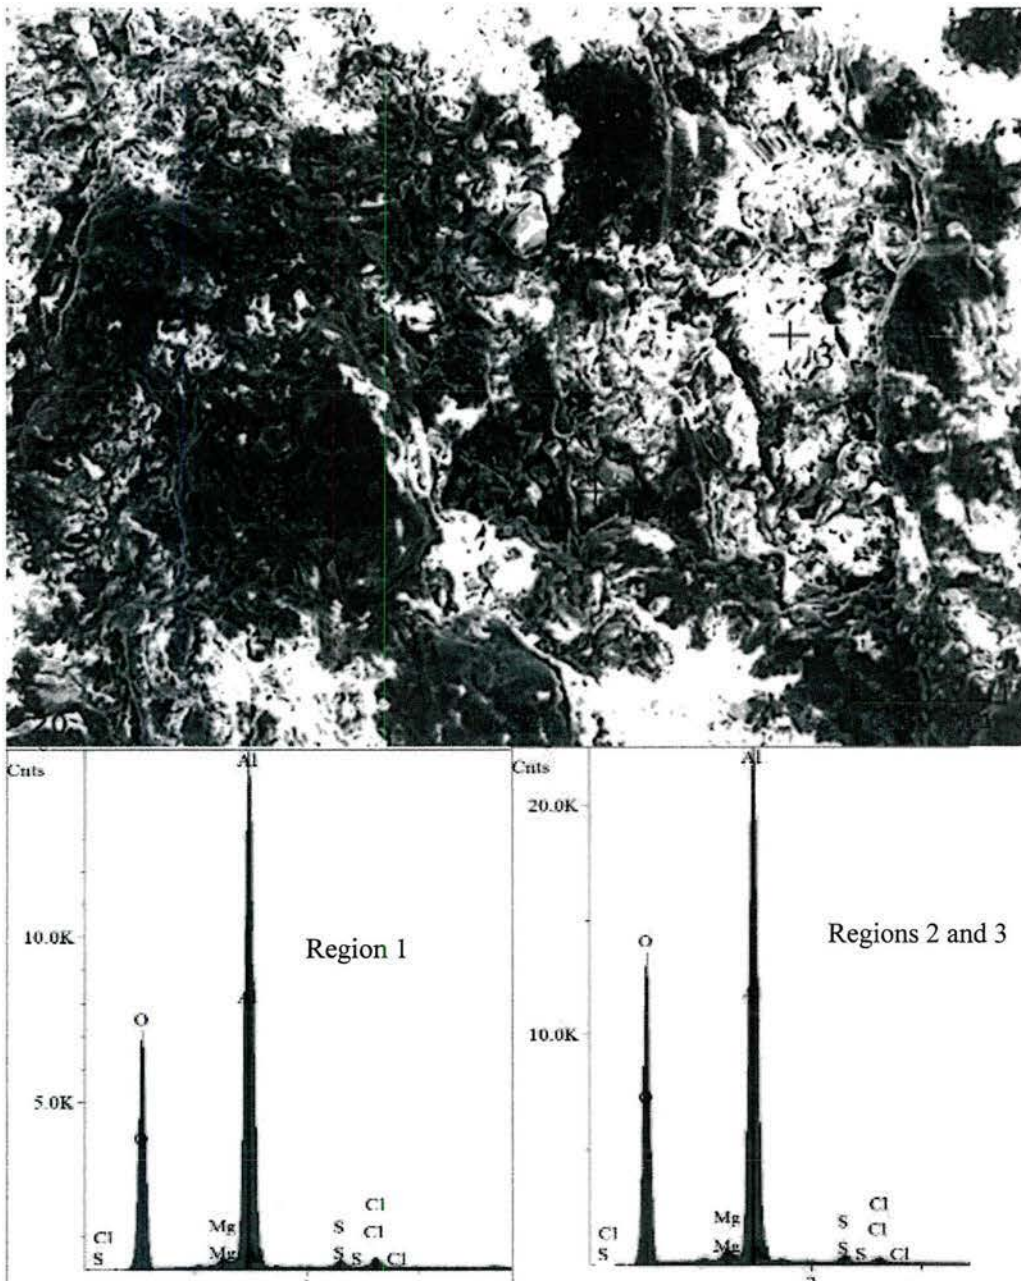
Figure 15 - SEM Photomicrograph of Fracture Surface (Mag 169x) and Non-dispersive X-ray Analysis of 3 Regions

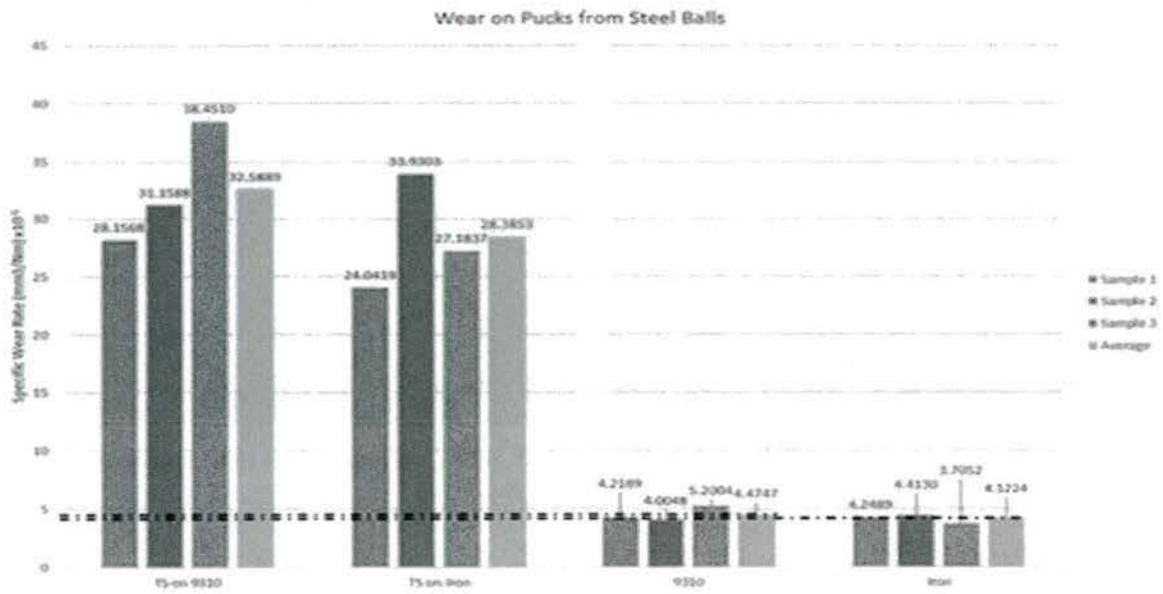
Figure 31. Comparison of Specific Wear Rates of Substrate Materials and Thermal Sprayed Alloy 420 Coatings

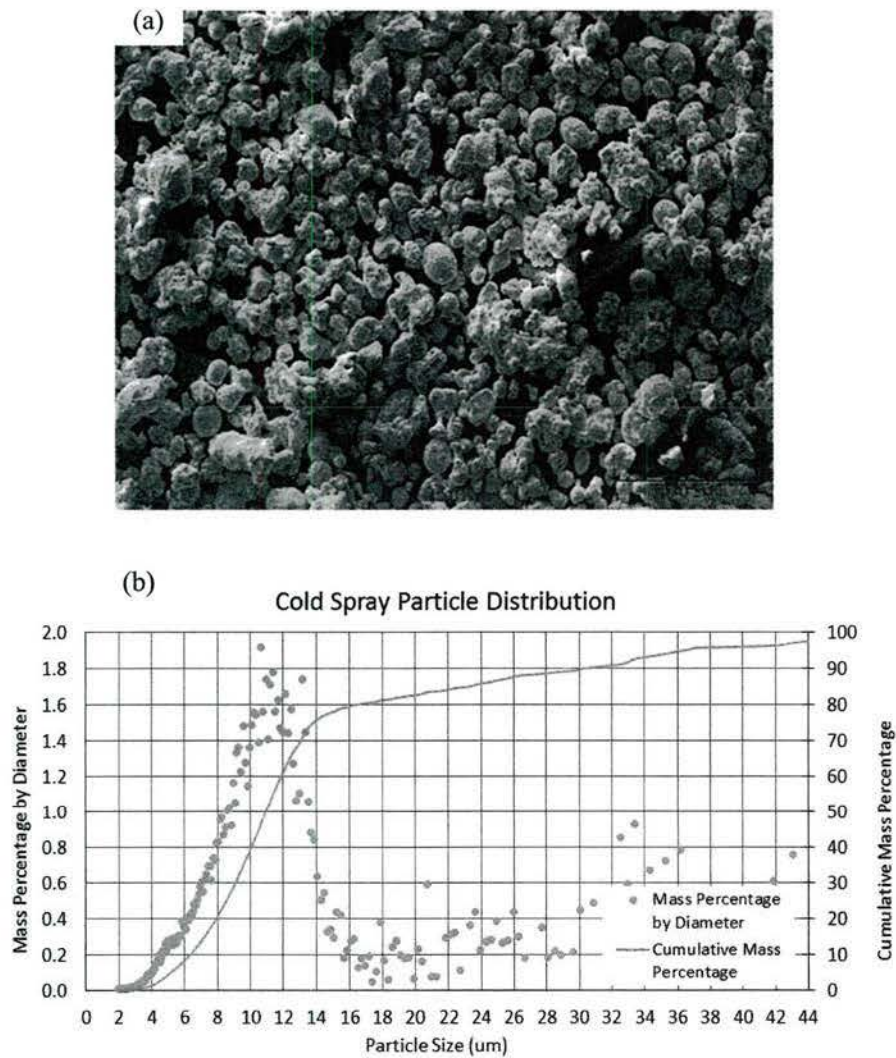
Figure 42: (a) SEM image of Cu particles, 250x, (b) Cu particle size distribution

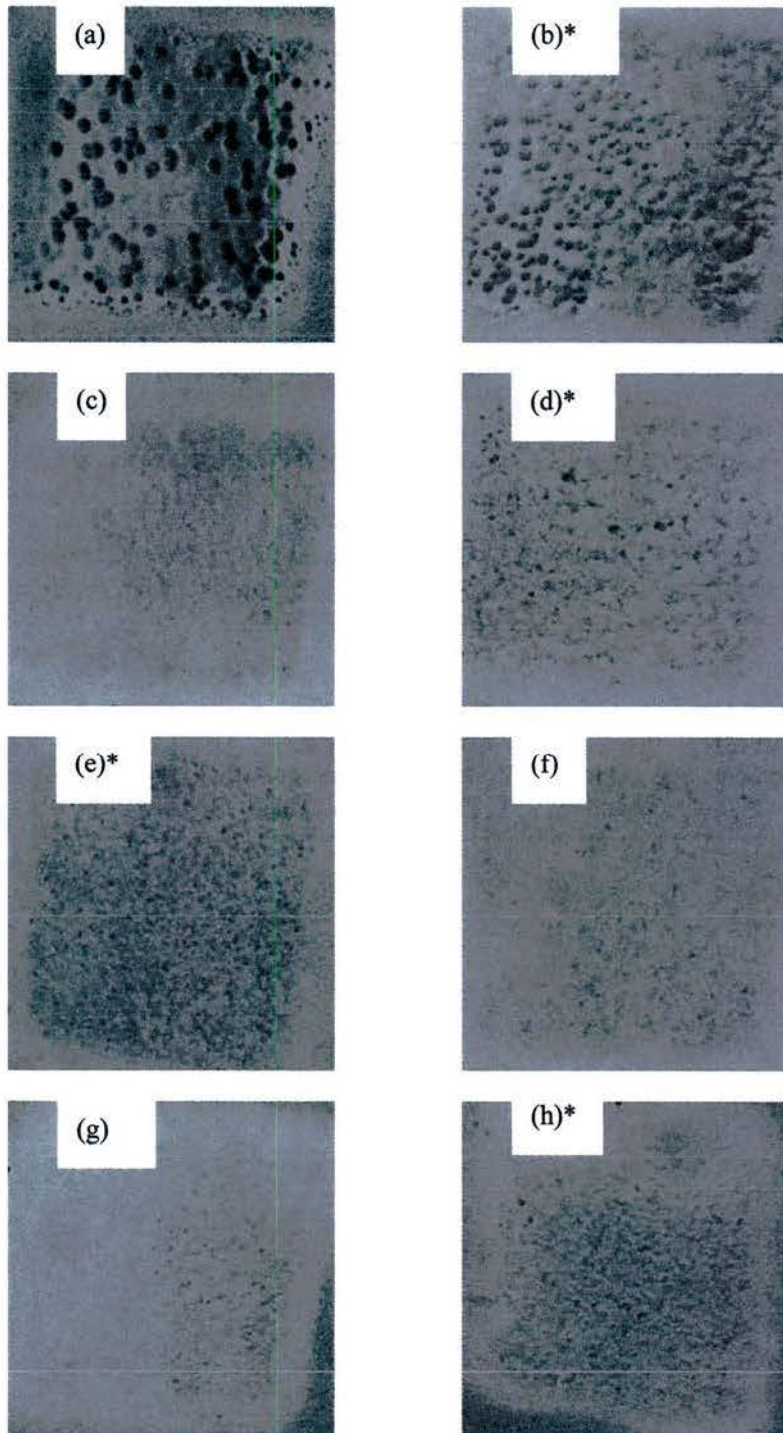
Figure 49: Iteration 3 coatings (a) #14-25mm SOD, 480°C, 5mm/s (b) #15-25mm SOD, 240°C, 5mm/s (c) #16-50mm SOD, 240°C, 5mm/s (d) #17-50mm SOD, 480°C, 5mm/s (e) #18-50mm SOD, 480°C, 20mm/s (f) #19-50mm SOD, 240°C, 20mm/s (g) #20-25mm SOD, 240°C, 20mm/s (h) #21-25mm SOD, 480°C, 20mm/s. Items with an * were selected for evaluation.

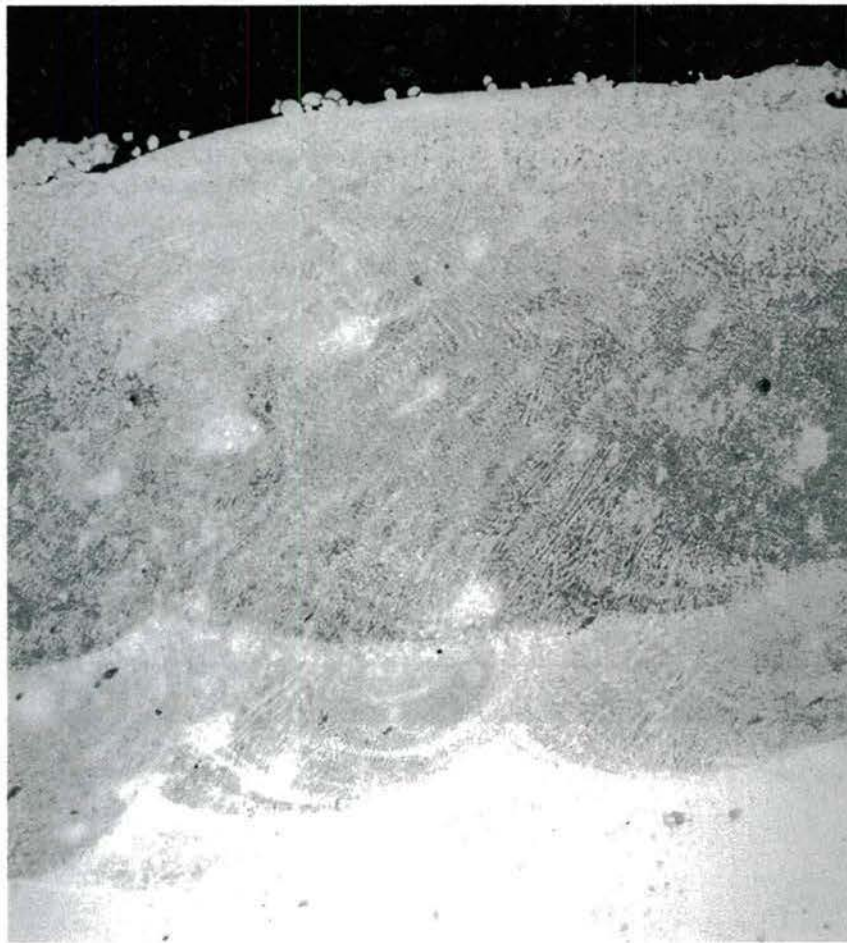
Figure 83: 50x image of optimal settings for 9310H Alloy Steel

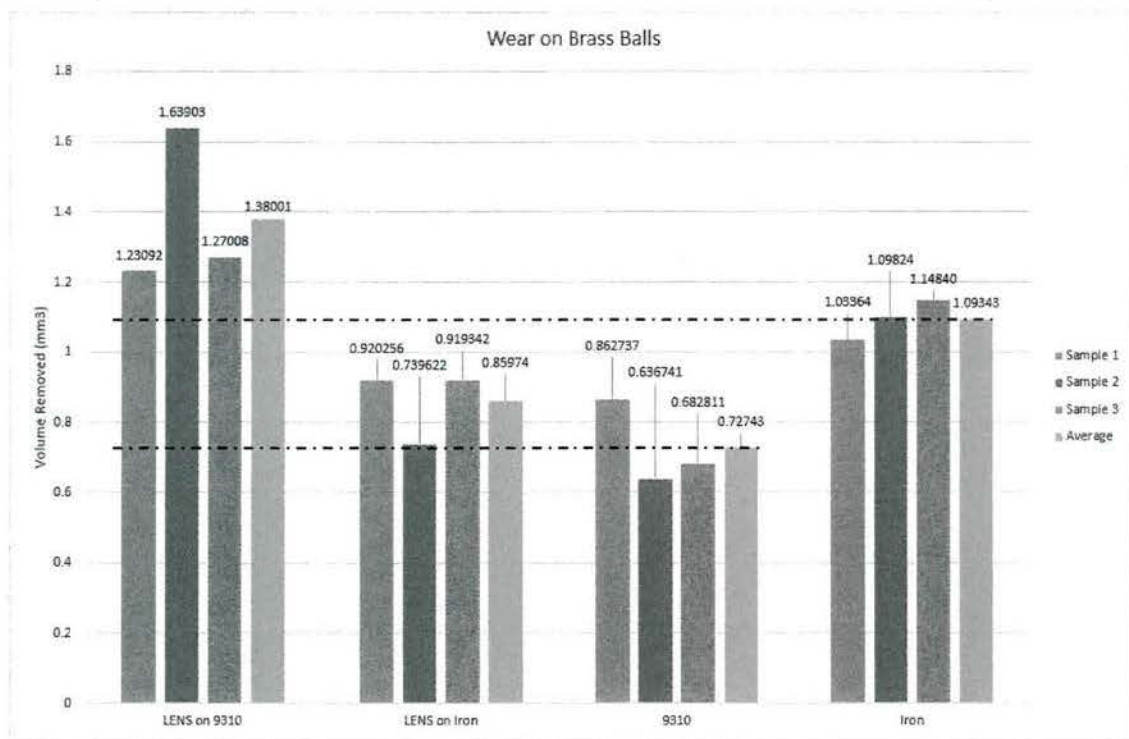
Figure 85: Graph showing volume removed on brass balls through wear testing of samples

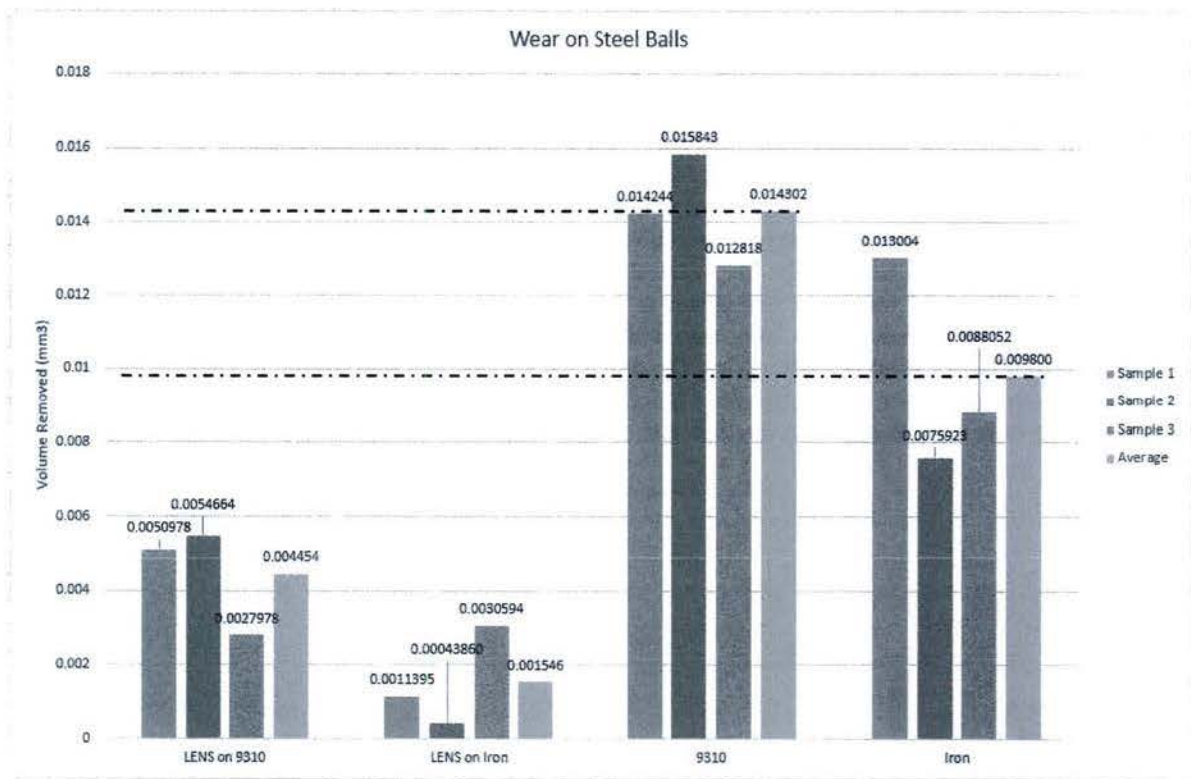
Figure 86: Graph showing volume removed on steel balls through wear testing of samples

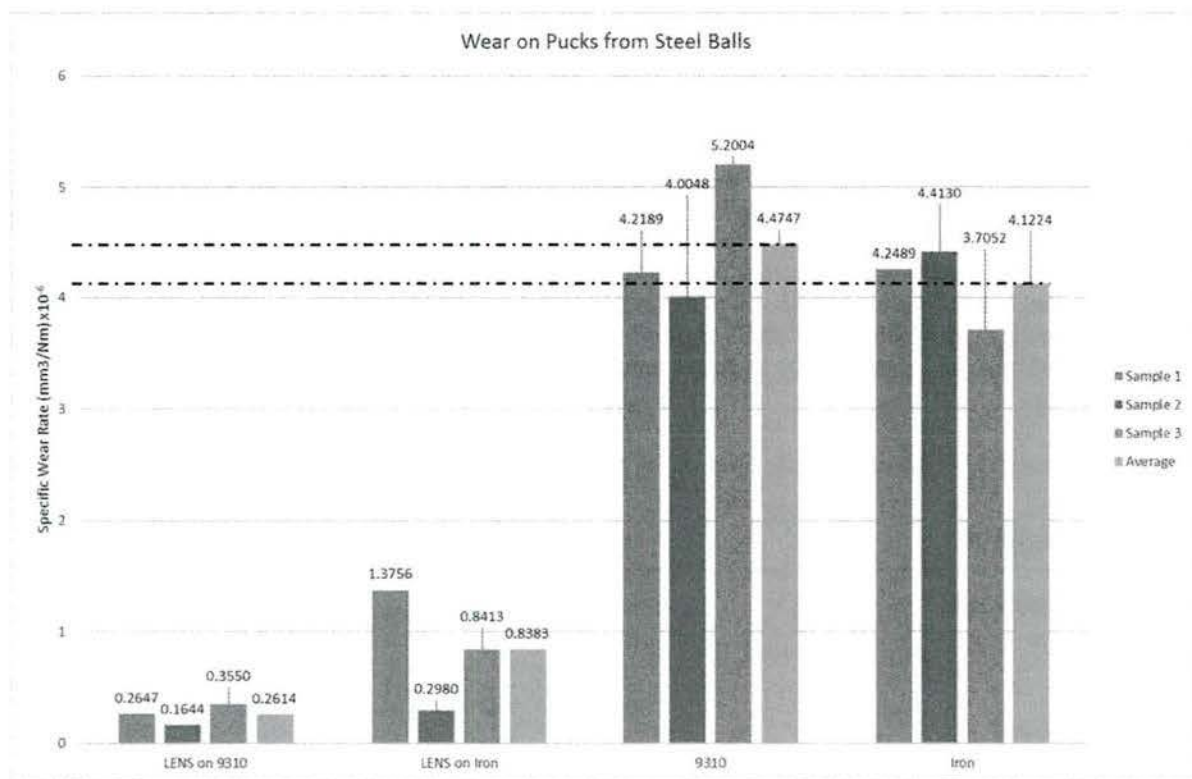
Figure 87: Graph showing wear rate of coatings and substrate benchmarks from wear testing
